**CALIFORNIA REGIONAL WATER QUALITY CONTROL BOARD
SAN DIEGO REGION**

**PRELIMINARY
TECHNICAL ANALYSIS
SUPPORTING**

**ADMINISTRATIVE CIVIL LIABILITY
AGAINST**

**SAN DIEGO UNIFIED SCHOOL DISTRICT
FOR
FAILURE TO COMPLY
WITH**

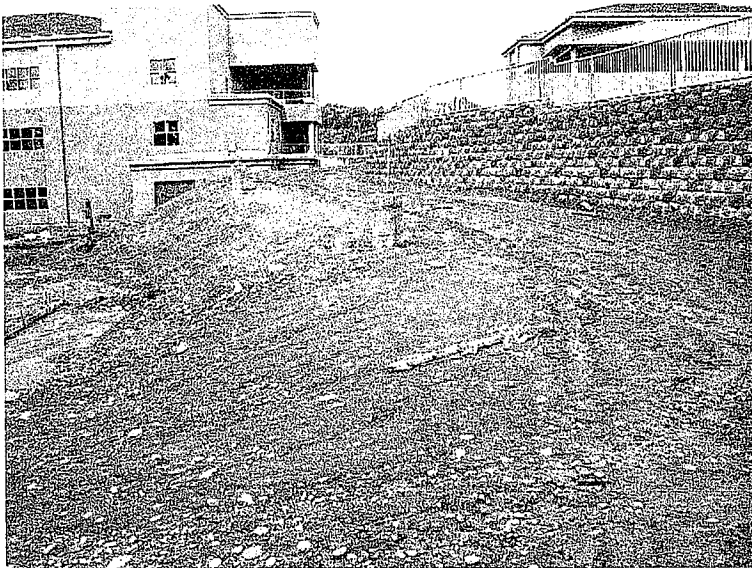
192. A slope has no erosion or sediment controls. A construction access road has no sediment controls.

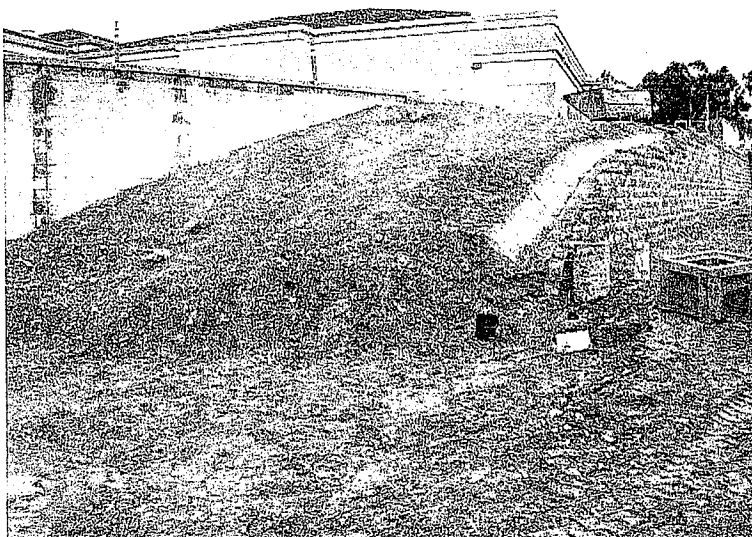
200. A slope with no erosion or sediment controls.

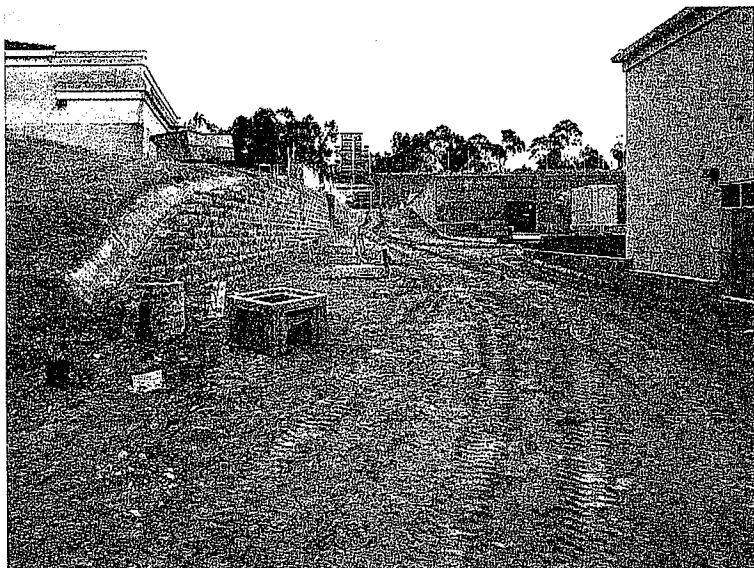
201. A construction access road with no sediment controls.

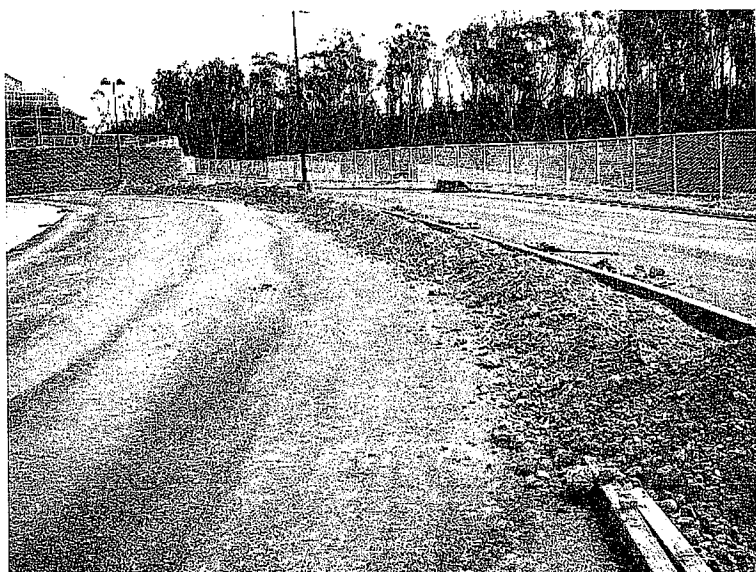
193. Dirt stockpiled on the street with no controls to minimize contact with runoff.

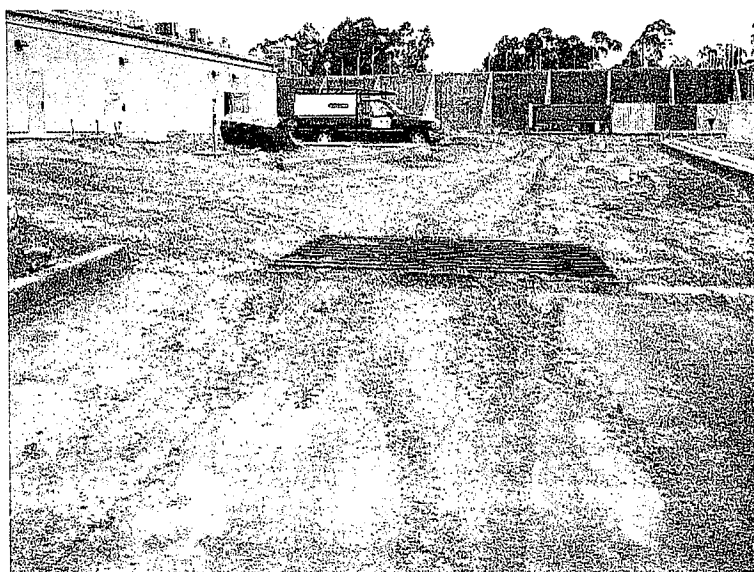
198. Construction exit has inadequate BMPs to prevent sediment tracking. They have one rumble plate and no gravel. Significant amounts of sediment have been tracked onto the paved surface.

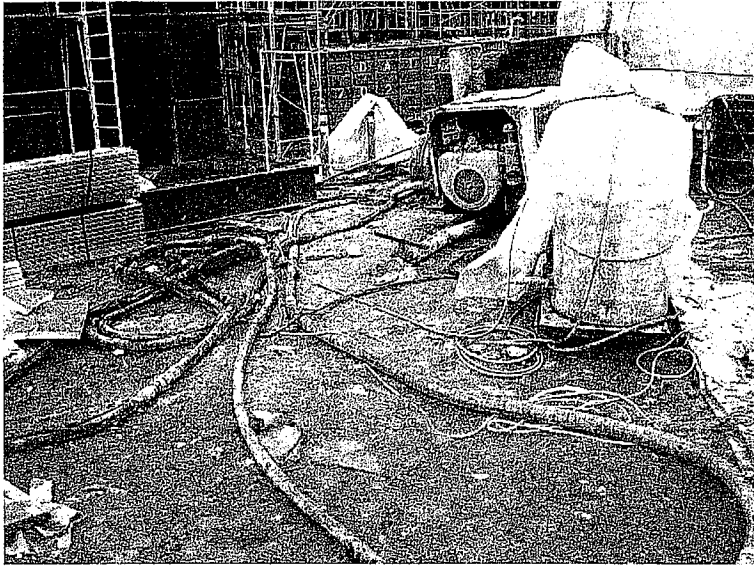
199. Material spills are on the ground with no containment to minimize contact with runoff.

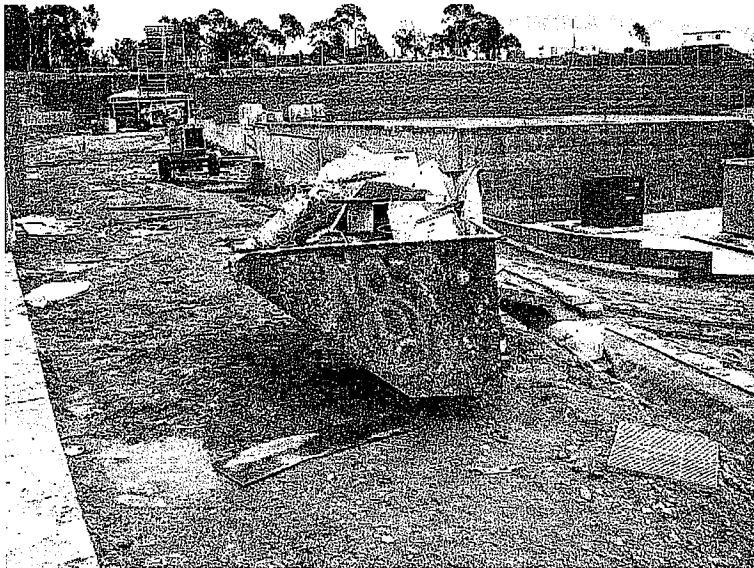
204. Construction trash is not covered to minimize contact with storm water.

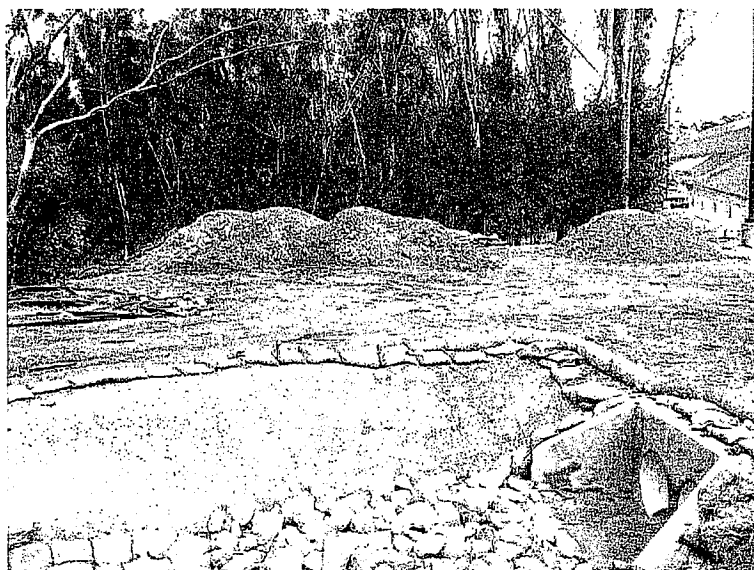
210. Soil stockpiles near Carroll Canyon Creek do not have cover or containment.

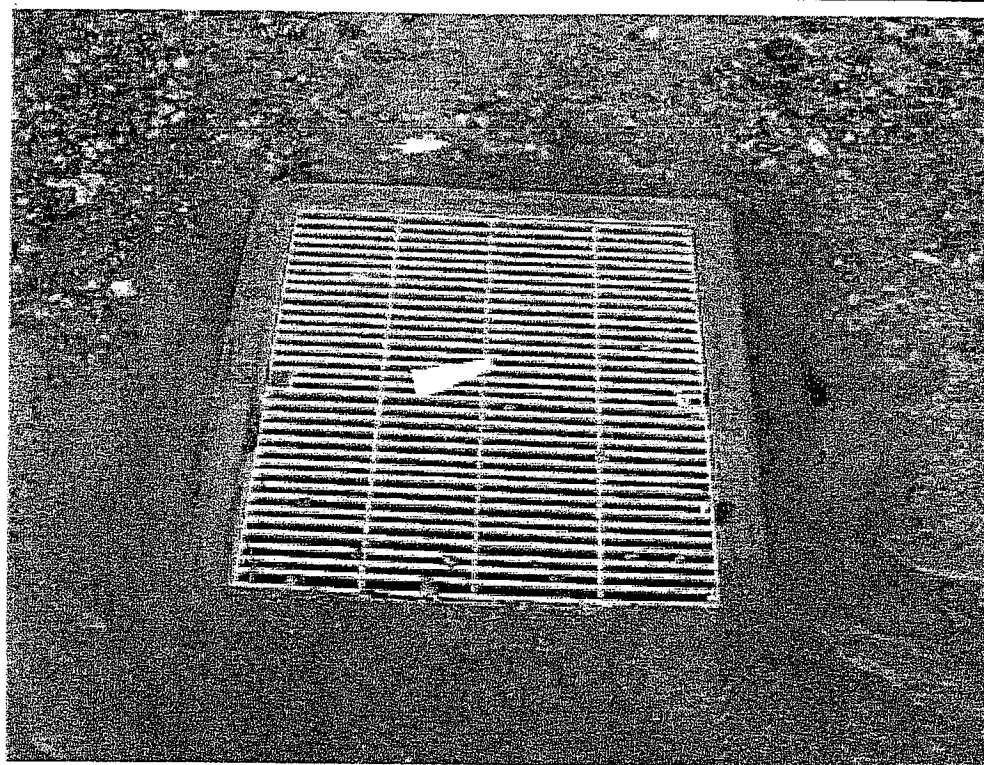
Photograph #11

Comments:
Drain inlet near building in north central portion of site with no protection.

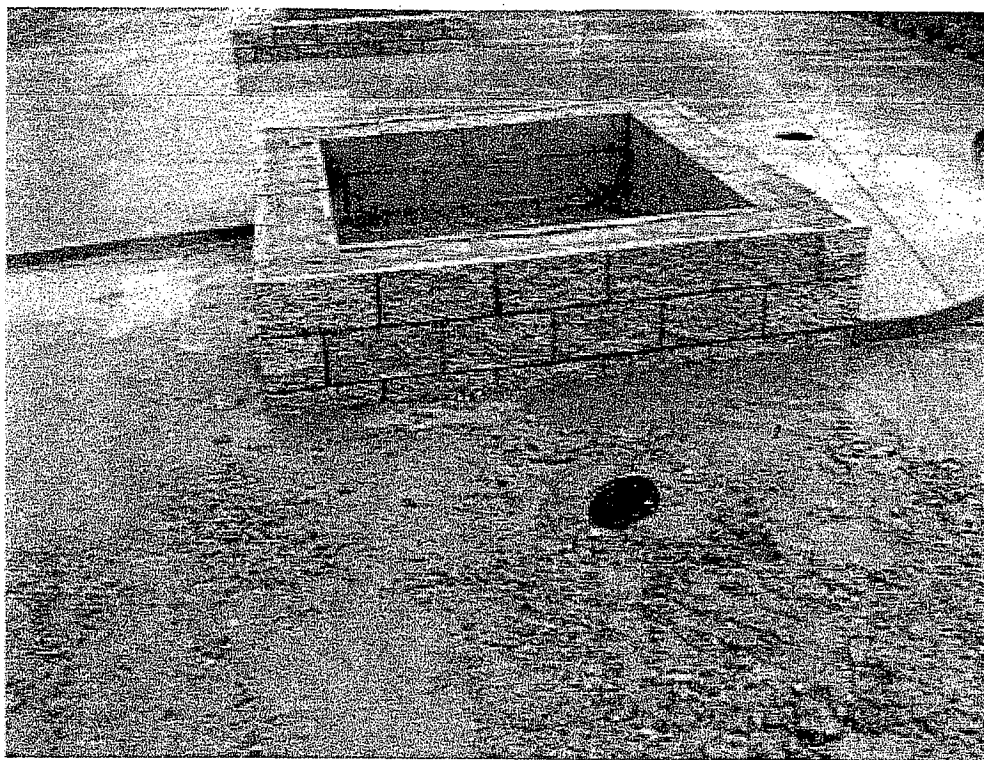
Photograph #13

Comments:
Storm drain stub up located at grade and receiving runoff.

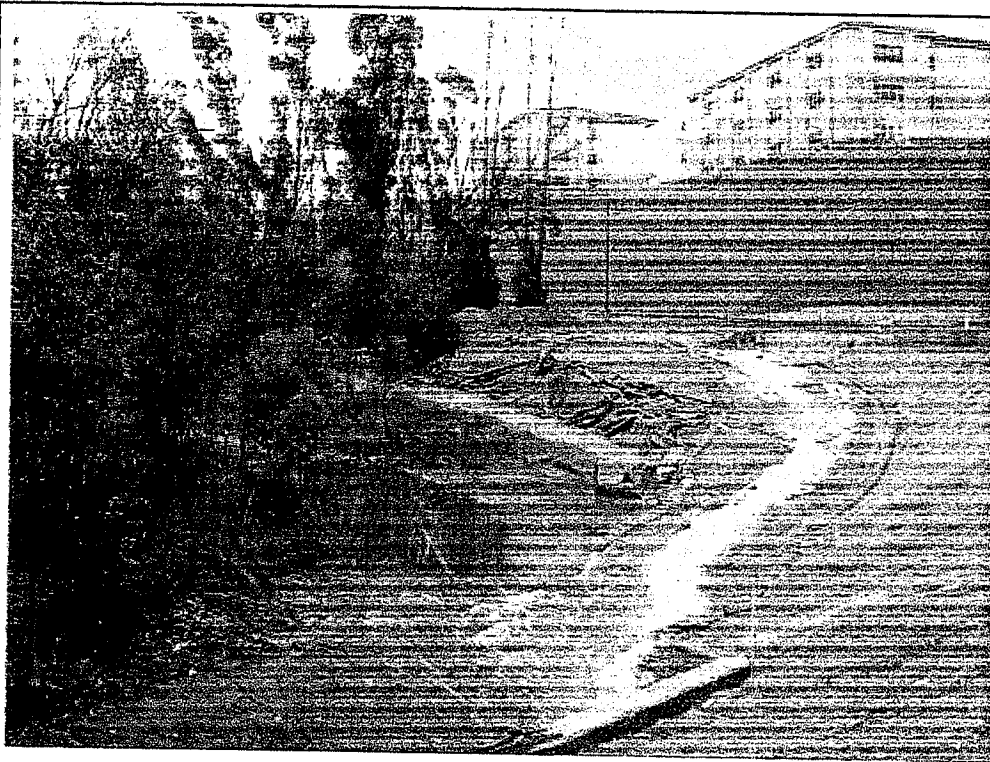
Photograph #5

Comments:
Stormwater runoff from north of Avenue of Nations outfall commingling with Carroll Canyon Creek.
